# Manhole Inspection Summary

Manhole # S35KK1010MH

Insp Date: **3/12/07 10:18 AM**

**Location** Address: **4303 UNDERWOOD RD**

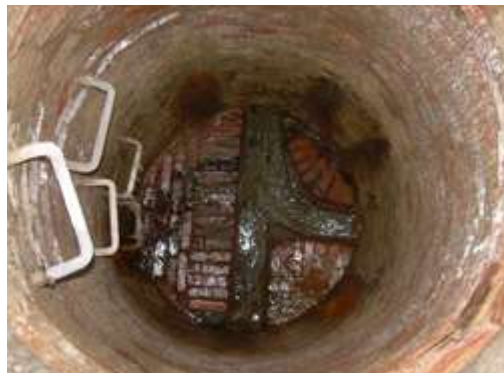
Top View

Corroded steps. Evidence of surcharge - Bench debris.

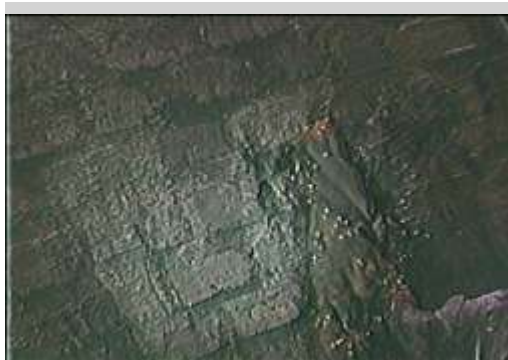
Defect

Barrel deterioration and infiltration (Active).

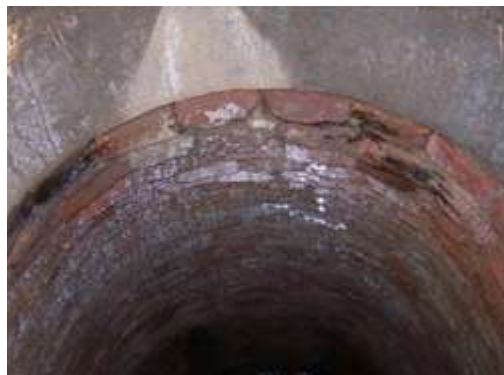
Defect

Adjustment deterioration and infiltration. Barrel infiltration.

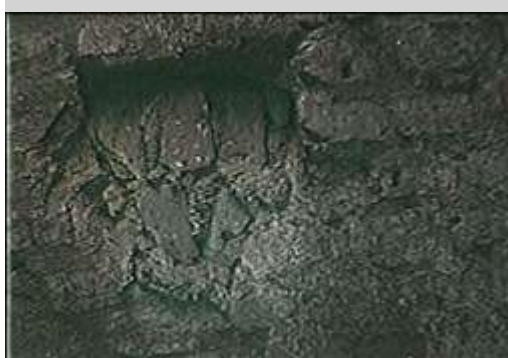
Defect

Barrel deterioration and infiltration.

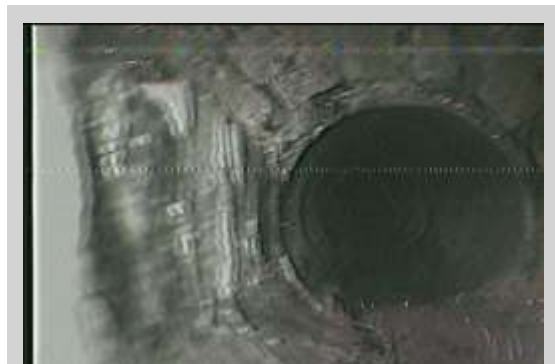
Pipe Out @ 12 O'Clock

Infiltration: **Evidence** Pipe Seal Cond: **Unknown**

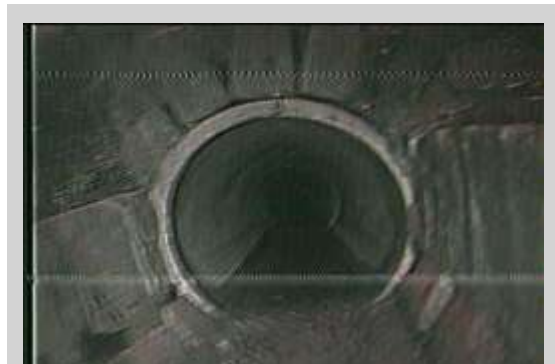
Pipe In @ 3 O'Clock

Infiltration: **Evidence** Pipe Seal Cond: **Unknown**

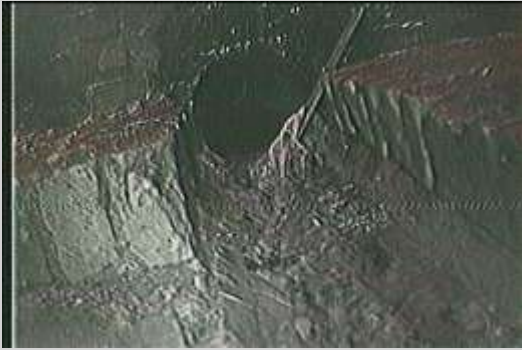
Pipe In @ 6 O'Clock

Barrel deterioration and infiltration. Channel deterioration.
